Waxdale Creek  
&  
Related Tributary

Pike River Watershed

**WATER QUALITY STANDARDS REVIEW  
AND STREAM CLASSIFICATION FOR WAXDALE CREEK  
AND A RELATED TRIBUTARY, PIKE RIVER WATERSHED  
RACINE COUNTY, WISCONSIN  
OCTOBER 1993**

by Tom Burzynski, Southeast District

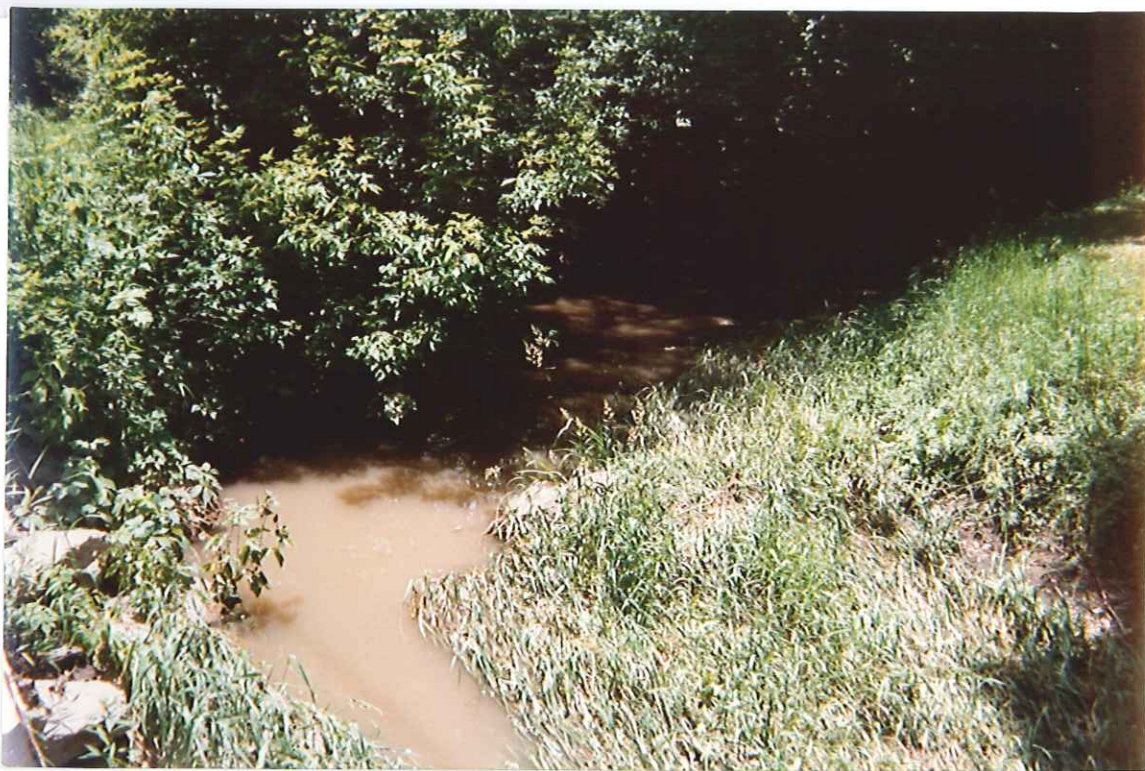
Figure 1. Waxdale Creek at 90th Street, Sturtevant. Starting point for fish assemblage collection. Note the woody bank vegetation at left and evidence of high flows at lower right.

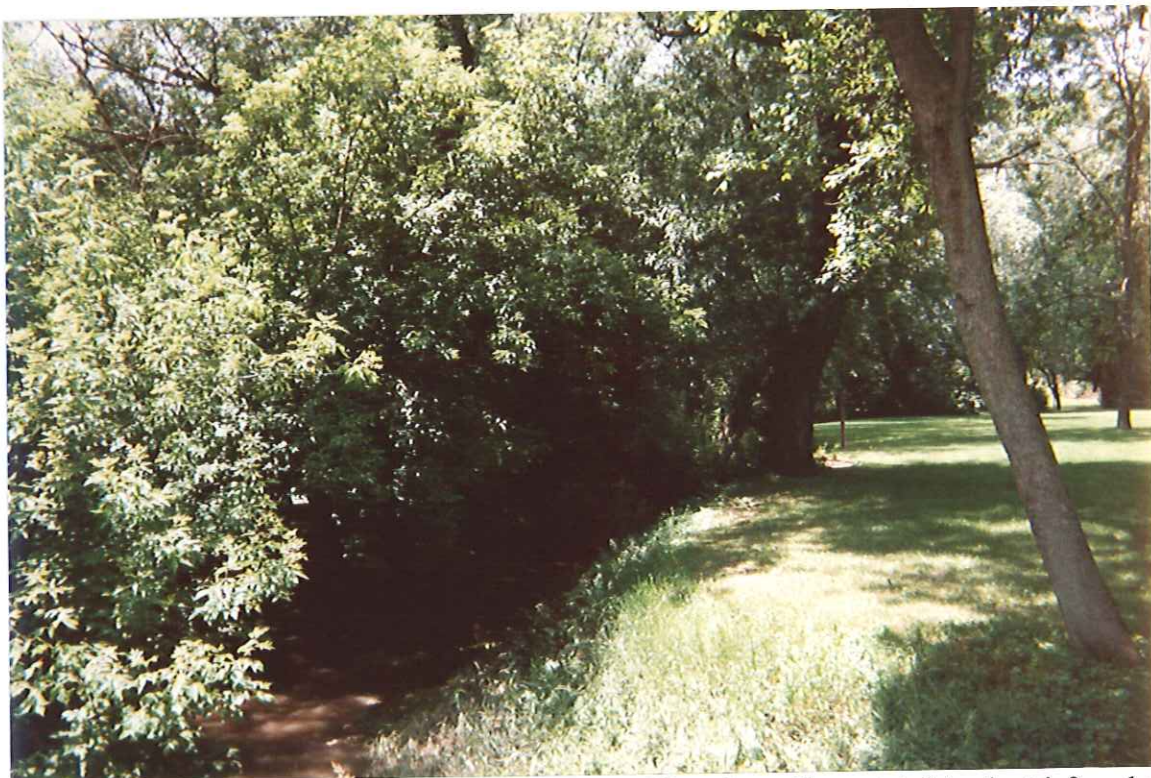
Figure 2. Waxdale Creek at 90th Street, Sturtevant. Note the well-vegetated bank at left and the residential lawns on the right. Banks are relatively stable with the exception of the right bank (at left in photo), which lacks stable understory growth.

- c. Protect and restore riparian habitats. Encourage the growth of woody vegetation along the stream channel and corridor to improve bank stability, provide wildlife habitat, and aid in moderating water temperatures through shading of the stream channel.

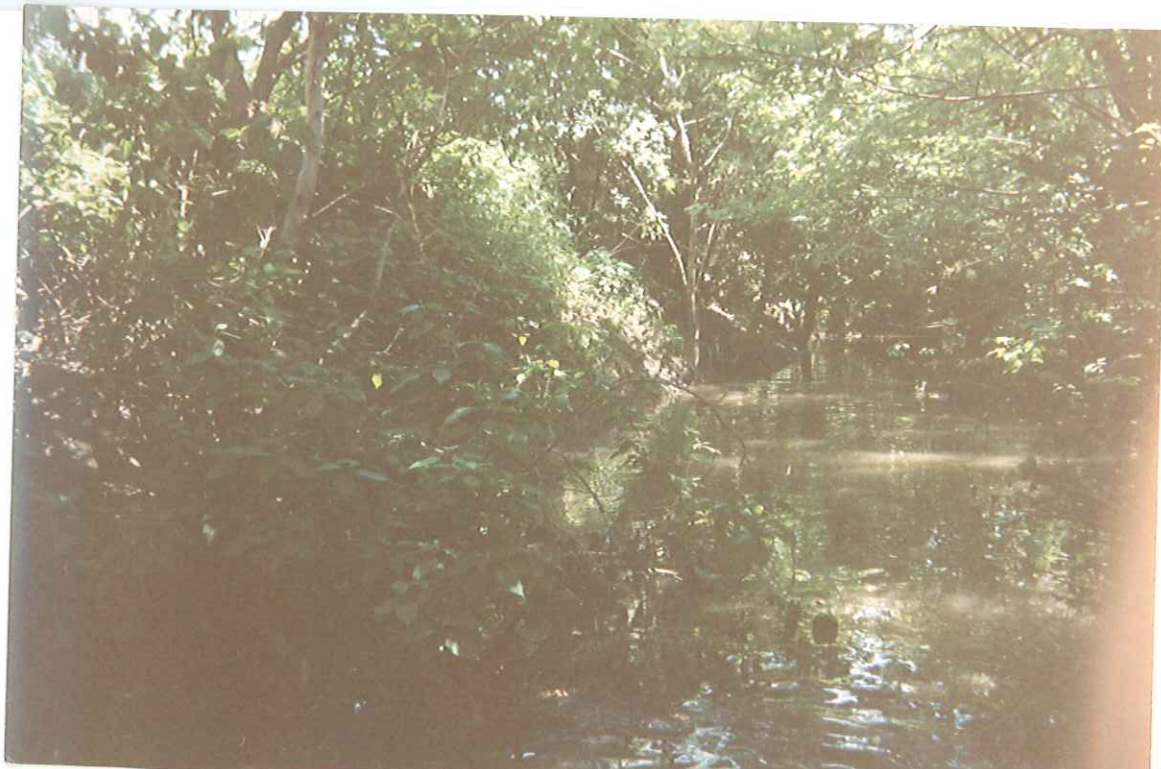
Habitat quality was rated poor at all sites sampled on Waxdale Creek and its tributary. Fish and aquatic life cover at the Waxdale tributary site is provided by overhanging bank vegetation and an occasional woody snag. The substrate consists mainly of silt, sand, and some gravel. Bank vegetation consists primarily of grasses and forbs, with woody vegetation limited to a few shrubs and immature trees. Fish and aquatic life cover on Waxdale Creek at 90th Street is provided by overhanging bank vegetation, woody snags, and scattered rubble/cobble. The substrate consists primarily of silt and sand with small areas of gravel also present. Bank vegetation at this site is generally well-developed and consists of mature trees, shrubs, and residential lawns. Understory vegetation on the wooded right bank is rather sparse, however, making it susceptible to erosion at high flows. At the Willow Road site on Waxdale Creek fish and aquatic life cover is provided exclusively by woody snags. The substrate is dominated by heavy deposits of silt overlying clay hardpan. Bank vegetation consists of mature trees and shrubs but the understory vegetation is very sparse, contributing to erosion at high flows.

Figure 3. Waxdale Creek upstream of Willow Road, Sturtevant. Bank vegetation is well established with the exception of understory growth, which is rather sparse. Substrate in this reach is exclusively composed of silt and muck over clay.

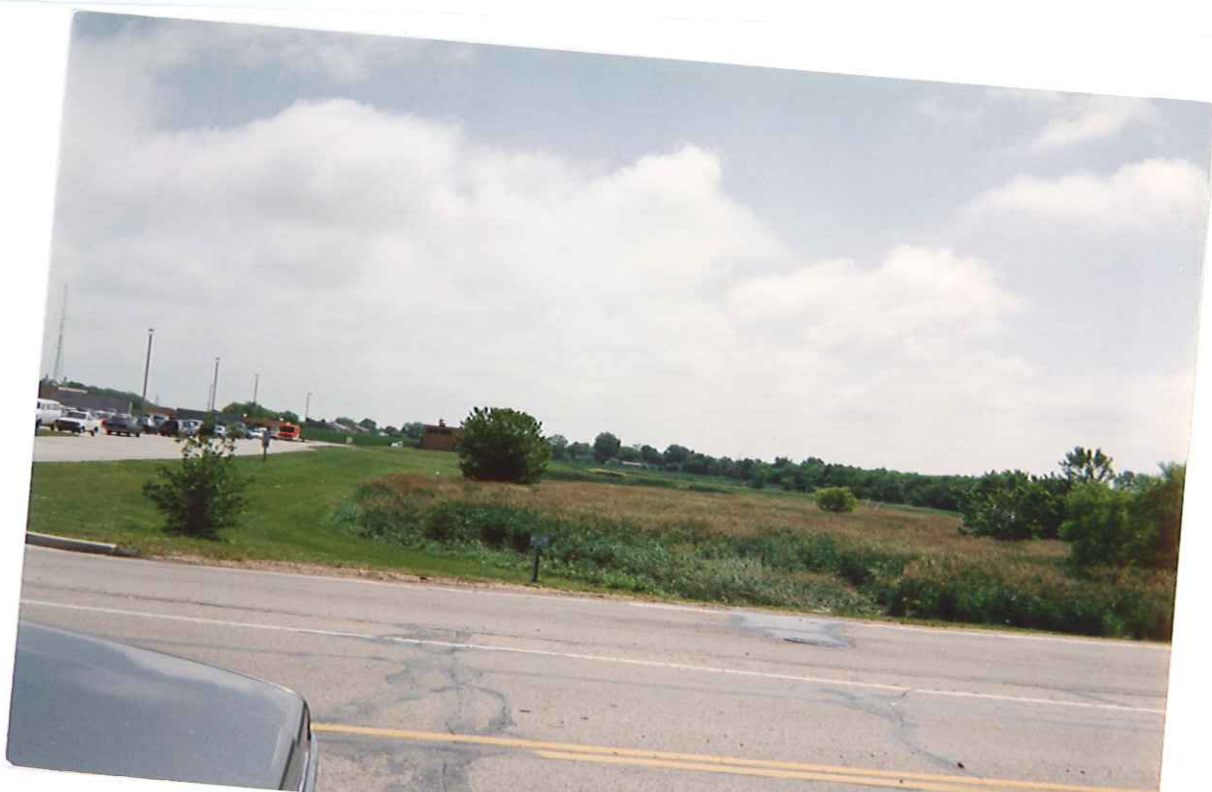
Figure 5. Waxdale tributary downstream of CTH H, Racine County. Wetland borders the stream channel along most of this reach. Such 'buffer zones' would be desirable in floodplain management to store large volumes of stormwater before entering the stream channel.

- d. Limit future development within the floodplain to protect riparian habitats.
  - e. Implement best management practices to reduce sedimentation from nonpoint sources of pollution.
